Manhole Inspection Summary

Manhole # S330__046MH

Insp Date: **3/18/08 11:30 AM**

Location Address: **190 hamburg**

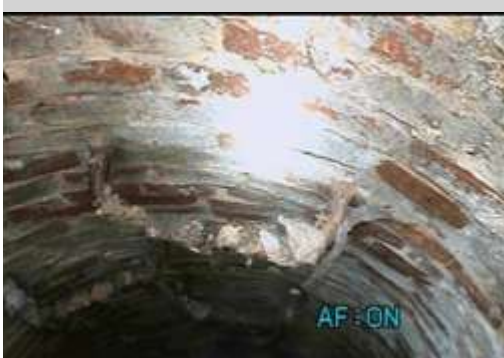
Defect 6

☒ **Evidence Of Surcharge** Depth: **4** (ft.) ☐ Active Surcharge Present

SURCHARGE

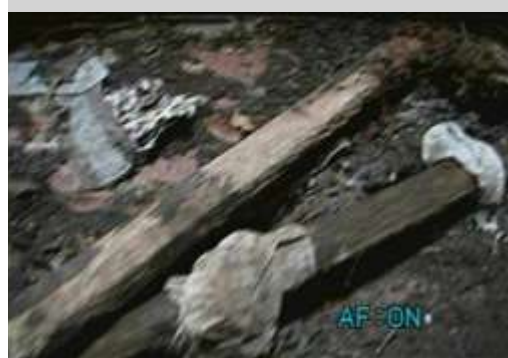
Defect 5

Condition: ☐ Sound ☐ Cracked ☐ Root Intrusion ☐ Deteriorated ☐ Leaks ☒ **Debris**

channel debris

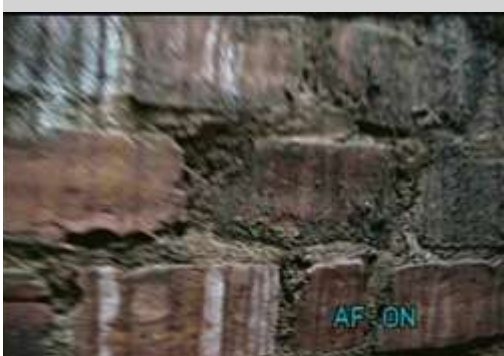
Defect 4

Infiltration: ☐ None ☐ Joint ☐ Cracks ☒ **Mortar** ☐ Roots ☐ Wall

infiltration marks on barrel

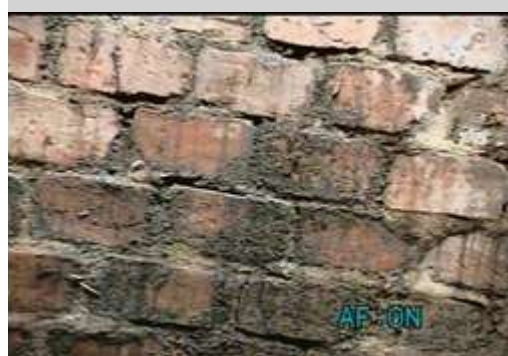
Defect 3

infiltration marks

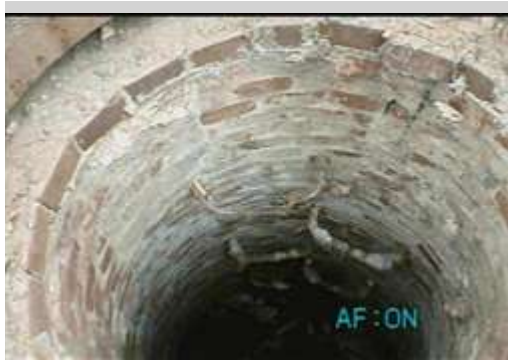
Defect 2

Count: **6** Missing: **1** ☒ **Corroded**

steps

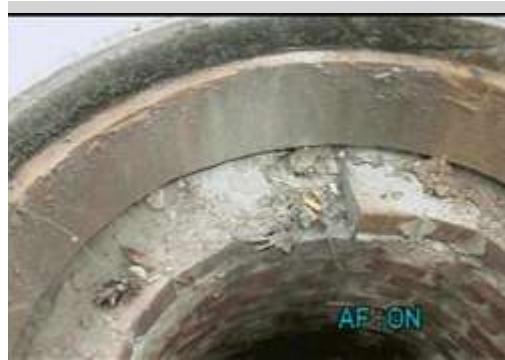
Defect 1

Offset: **3** (in.)

Condition: ☐ Sound ☐ Cracked ☐ Root Intrusion ☒ **Loose Brick** ☐ Deteriorated

chimney loose bricks, offset

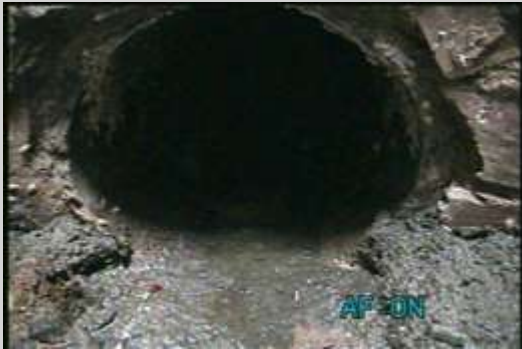
12 O'Clock Outflow

Deposits: ☐ None ☒ **Mud** ☐ Sludge ☐ Debris ☐ Grease

Silt Depth: 1 (in.) Deposits Extent: **Light**
